Care and Maintenance of Bearings (Revised)

This booklet is intended as a guide to bearing maintenance, with the main consideration being on-site bearing maintenance.

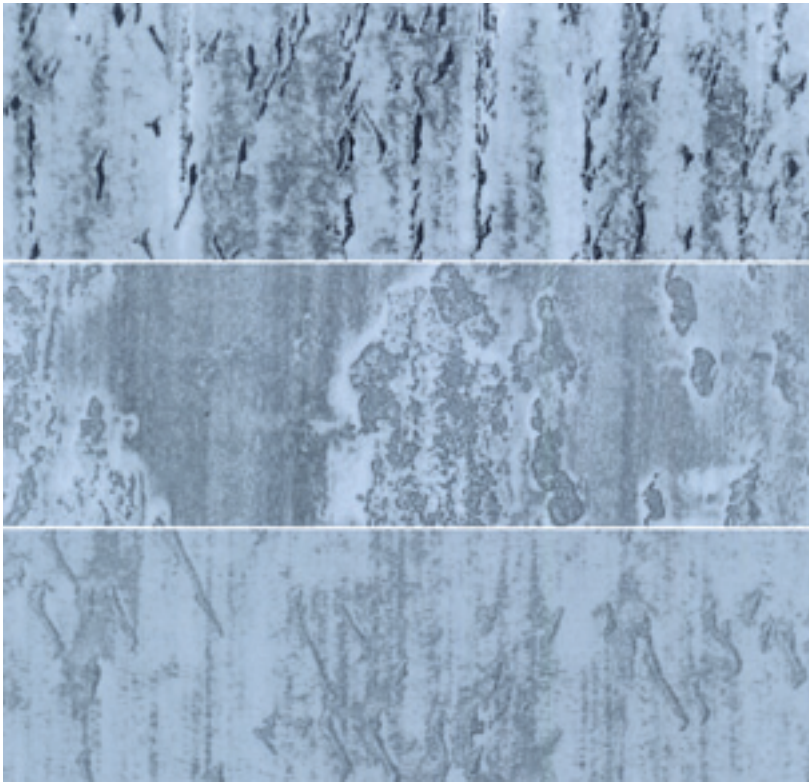
Explanation of the Photos. These are microscopic photographs of peeling damage generated on the surface of a ball/roller bearing. Peeling can occur when the surface roughness is high, or when the lubrication performance is poor. Peeling has a flat-colored appearance, and when observed under a microscope, shows minute flaking and cracks. The top photo shows an example of minute flaking interconnected with cracks. The photo in the middle shows an example of partial separation of the surface, occurring after a number of areas where minute flaking occurred have been connected. This is often seen when grease lubrication is used. The bottom photo shows an example in which a directionality is seen in the minute flaking. The example also shows cracks due to slippage.

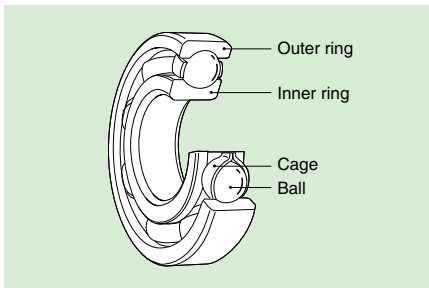
Fig. 5.1 Deep groove ball bearing

Figures 5.1 to 5.7 show the names of bearing parts referred to in the descriptions of the failure cases.

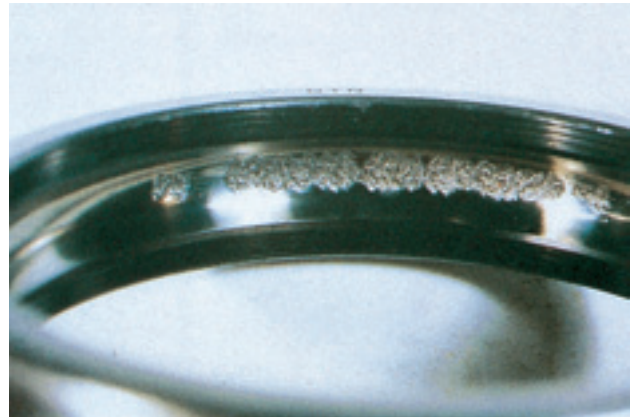
Photo A-2

- Outer ring of angular contact ball bearing
- Flaking of raceway surface spacing equal to distances between balls.
- The cause is improper handling.

Condition	Cause	Solution
Raceway surface is flaked. Surface after flaking is very rough.	Rolling fatigue. Flaking may be caused early by over-load, excessive load due to improper handling, poor shaft or housing accuracy, installation error, ingress of foreign objects, rusting, etc.	<ol style="list-style-type: none"> (1) Find the cause of the heavy load. (2) Examine operating conditions and adopt bearings with larger capacity as necessary. (3) Increase viscosity of oil and improve lubrication system to form an adequate lubricating oil film. (4) Eliminate installation errors.

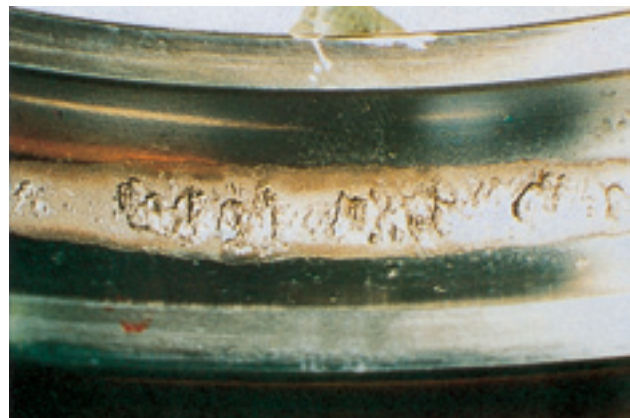
Photo A-4

- Outer ring raceway of an angular contact ball bearing

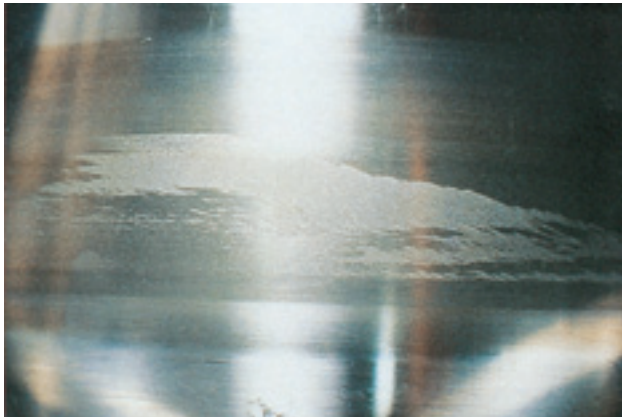
Photo D-1

- Inner ring of cylindrical roller bearing
- Smearing on raceway surface
- The cause is slippage of rollers due to foreign objects trapped within.

Condition	Cause	Solution
Surface is roughened and tiny particles adhere.	Rolling elements slip in rolling motion and characteristics of lubricant are too poor to prevent slippage.	<ol style="list-style-type: none"> (1) Select optimum lubricant and lubrication system capable of forming sound oil film. (2) Use a lubricant including extreme pressure additive. (3) Take precautions such as a small radial clearance and pre-load to prevent slippage.

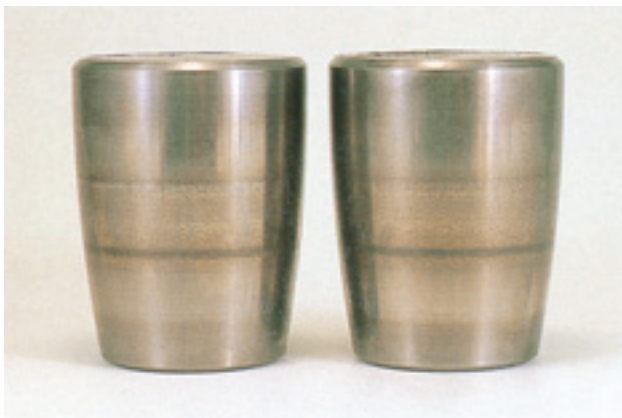
Photo D-3

- Rollers of spherical thrust roller bearings
- Smearing at middle of rolling contact surfaces
- The cause is slippage of rollers due to foreign objects trapped within.

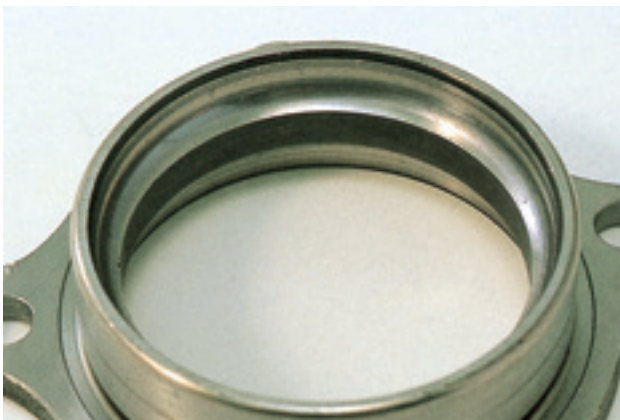
Photo E-3

- Outer ring of double row angular contact ball bearing (hub unit bearing)
- Wear on one side of the raceway
- The cause is poor lubrication.

Condition	Cause	Solution
Surface is worn and dimensions are reduced compared with other portions. Surface mostly roughened and scored.	Ingress of solid foreign objects. Dirt and other foreign objects in lubricant. Poor lubrication. Skewing of rollers.	(1) Selection of optimum lubricant and lubrication system (2) Improvement in sealing efficiency (3) Filtration of lubricating oil (4) Elimination of misalignment

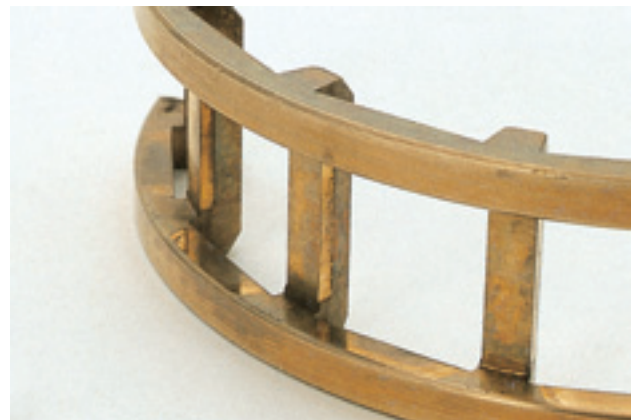
Photo E-4

- Retainer of cylindrical roller bearing
- Wear of pockets of machined high tensile brass casting retainer (G1)

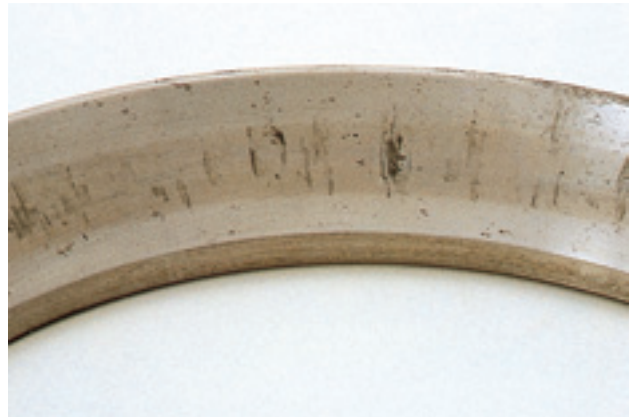
Photo J-2

- Outer ring of tapered roller bearing
- Rusting on raceway surface spacing equivalent to the distances between rollers. The cause is water in lubricant.
Some points are corroded.

Condition	Cause	Solution
Rusting or corrosion of bearing ring and rolling element surfaces Sometimes rusted at spacing equal to the distances between the rolling elements	Ingress of water or corrosive material (such as acid) Condensation of moisture contained in the air. Poor packaging and storing conditions, and handling with bare hands.	(1) Improvement in sealing effect (2) Periodic inspection of lubricating oil (3) Careful handling of bearing (4) Measures for preventing rusting when not operating for a long period of time.

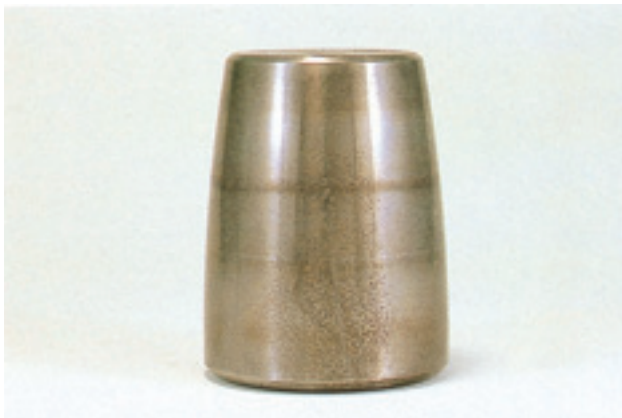
Photo J-3

- Roller of spherical roller bearing
- Rust as well as corrosion on rolling contact surface
- Ingress of water

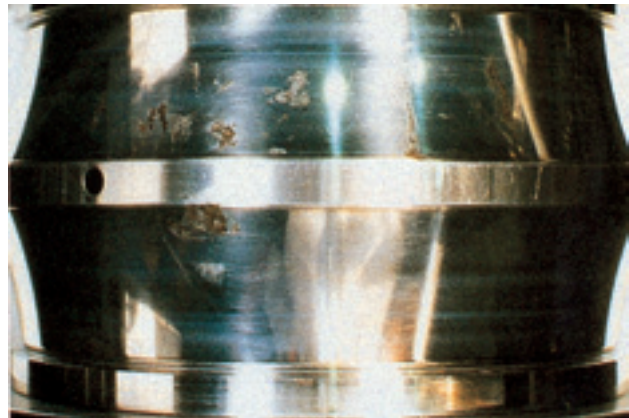
Photo J-4

- Inner ring (split type) of self-aligning roller bearing
- Rust and corrosion of the raceway surface
- The cause is ingress of water.

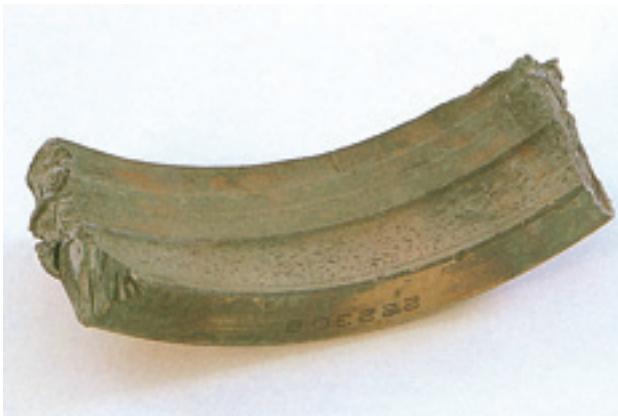
Photo K-3

- Outer ring of spherical roller bearing
- Stepped wear due to seizing up of raceway surface.
- The cause is poor lubrication.

Condition	Cause	Solution
<p>Bearing generates heat and is seized up by heat disabling spinning.</p> <p>Discoloration, softening, and welding of raceway surface, rolling contact surfaces, and rib surface.</p>	<p>Dissipation of heat generated by bearing is not enough. Poor lubrication or lubricant improper. Clearance excessively small.</p> <p>Excessive load (or pre-load),</p> <p>Roller skewing and installation error.</p>	<p>(1) Improve dissipation of heat from bearing</p> <p>(2) Selection of suitable lubricant and determination of optimum lubricant feeding rate.</p> <p>(3) Prevention of misalignment</p> <p>(4) Improvement in clearance and pre-load</p> <p>(5) Improvement in operating conditions</p>

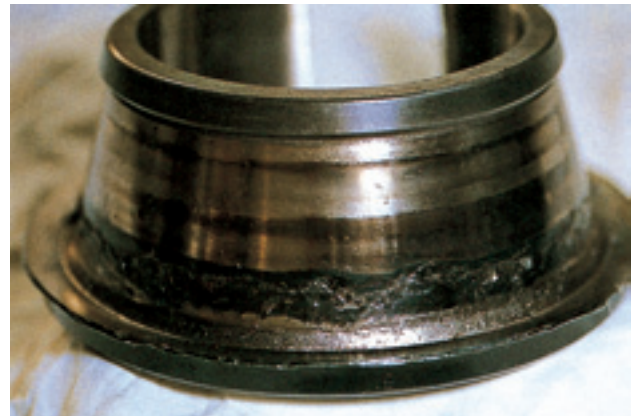
Photo K-4

- Inner ring of tapered roller bearing
- Large end of the race way surface and cone back face rib surface are seized up.
- The cause is poor lubrication.

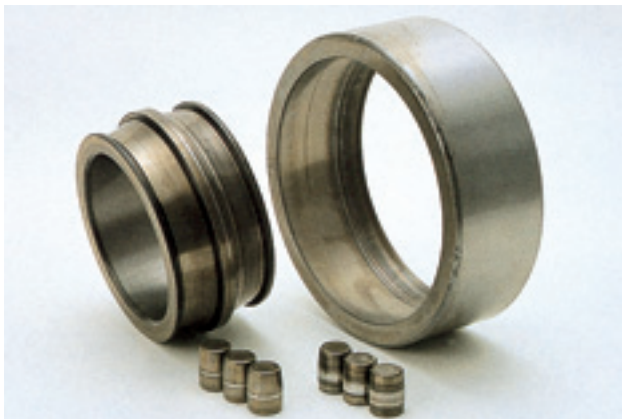
Photo N-1

- Spherical roller bearing
- Contacts on inner ring, outer ring, and rollers are not even.
- The cause is poor mounting.

Condition	Cause	Solution
Rolling element contact path on raceway surface strays or skews.	Deformation or tilt of bearing ring due to poor accuracy of shaft or housing Poor rigidity of shaft or housing Deflection of shaft due to excessive clearance	(1) Improvement in machining accuracy of shaft and housing (2) Improvement in rigidity of shaft and housing (3) Employment of adequate clearance

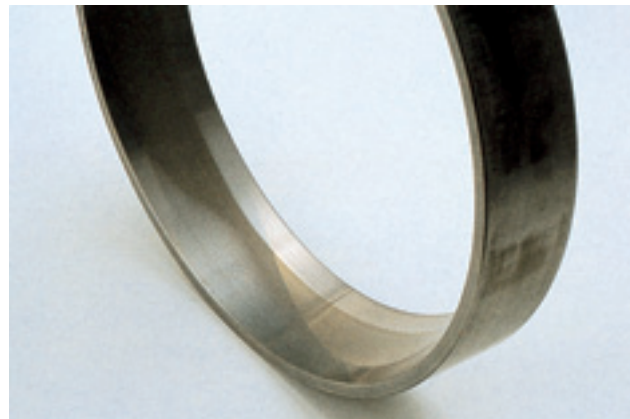
Photo N-2

- Outer ring of tapered roller bearings
- Contact path on raceway surface strays.
- The cause is poor mounting.

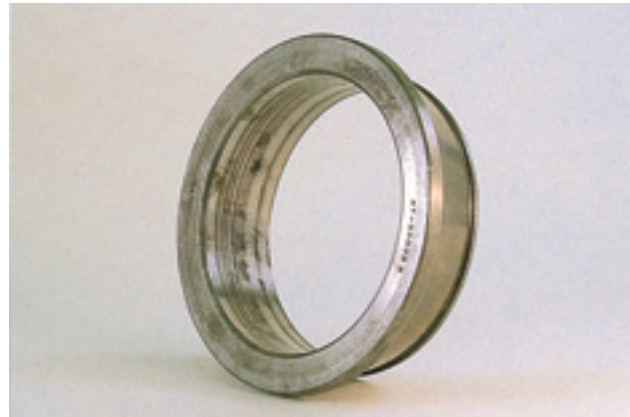
Photo P-2

- Inner ring of tapered roller bearing
- Spalling due to creep at the middle of bore wall

Condition	Cause	Solution
Fitting surfaces are glazed or matted, and sometimes spalled as well.	Fitting of inner ring is loose on inner ring drive bearing, and that of the outer ring is loose on outer ring drive bearing. If the housing is made of a light alloy such as aluminum, fit may become loose due to the difference of thermal expansion.	(1) Improvement in fit (2) Improvement in machining accuracy of shaft and housing

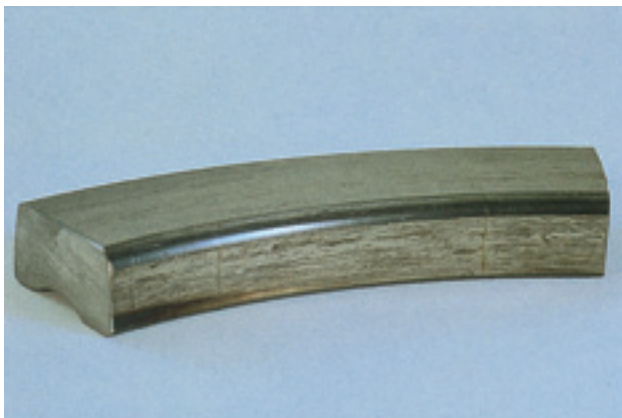
Photo P-3

- Inner ring of thrust ball bearing
- Spalling and friction cracking due to creep on bore wall.

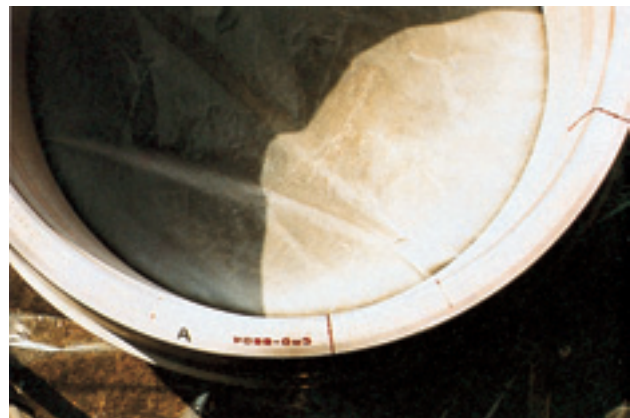
Photo P-4

- Inner ring of tapered roller bearing
- Spalling and friction cracking on width surface due to creep
Crack developed into a split reaching bore wall.
